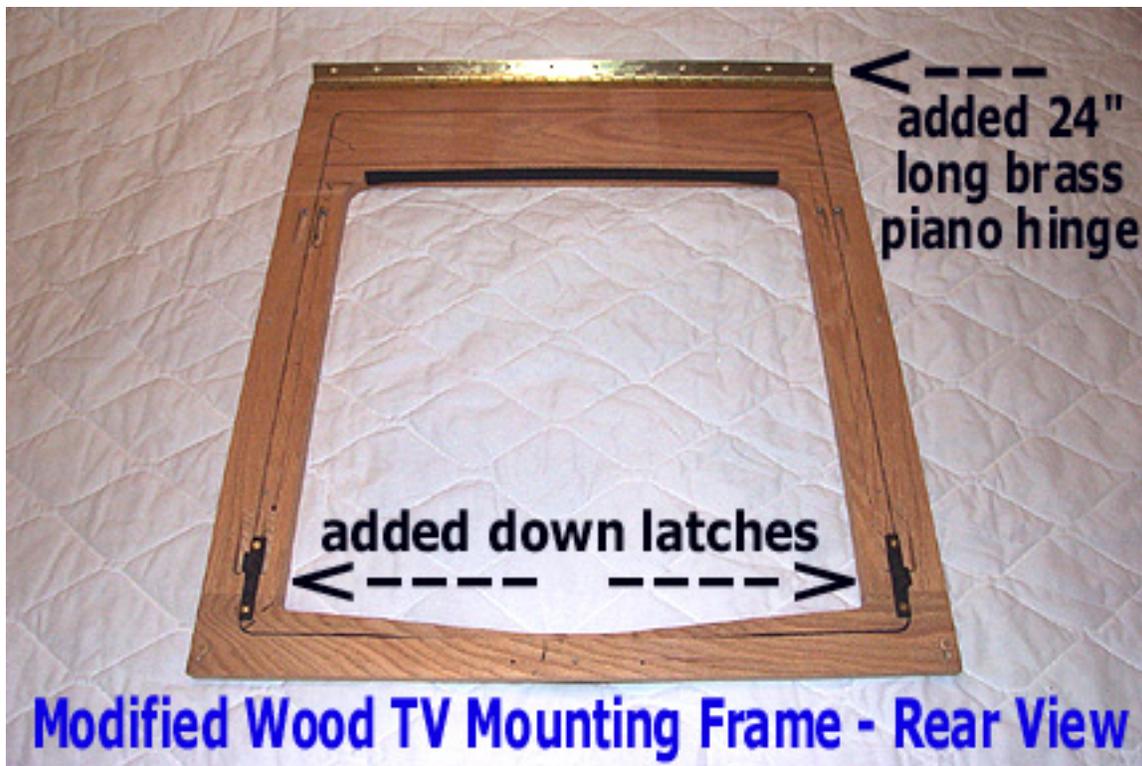
**PHOTO #8**

Photo #8 below shows the rear view of the removed and modified wood TV mounting frame.

A 1-1/2" wide by 24" long brass piano hinge is added along the top of the mounting frame that when attached to the top opening in the entertainment center converts this to a vertical opening door. Since this door will be equipped with two lift support gas cylinders that will hold it up in the open position, two down latches (one on each side) have been added at the bottom of the door as shown in Photo #8. The other half of these two latch assemblies can be seen attached to the bottom edges of the entertainment center opening in both Photo #4 and Photo #5 above.

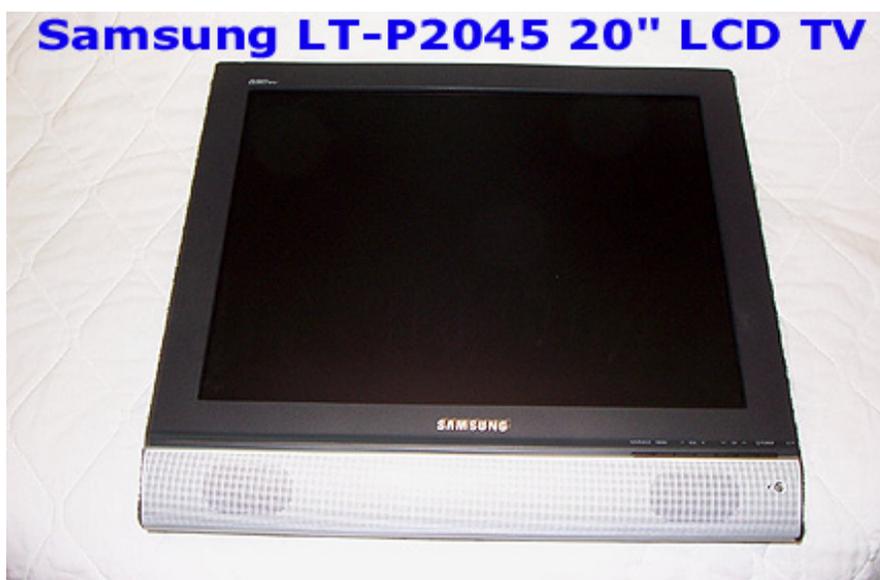
**PHOTO #9**

Photo #9 above shows the Samsung 20" LCD TV with its metal pedestal mounting base removed. This base must be removed to permit the mounting of the TV to the back side of the door.

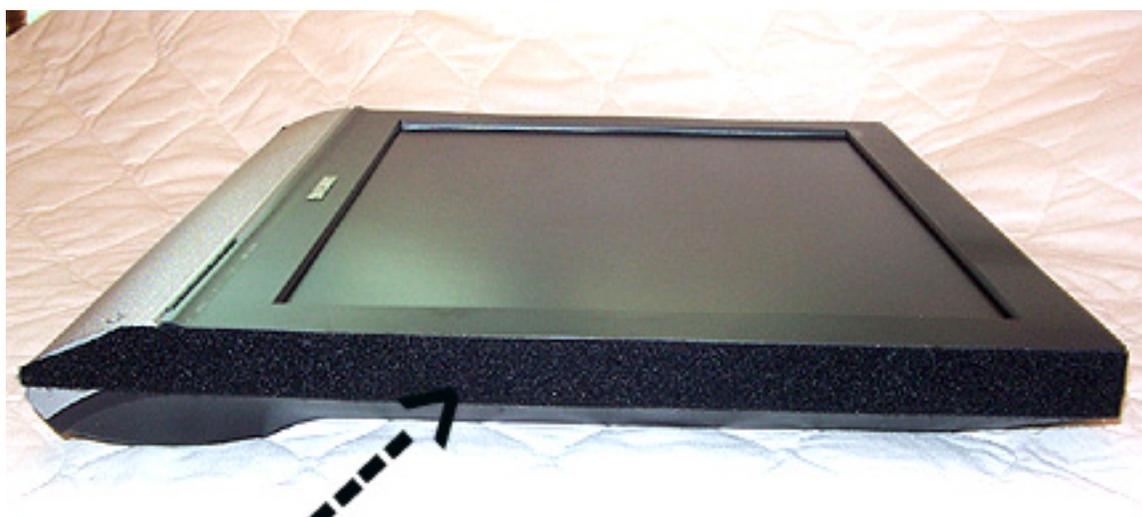
PHOTO #10

The 1" wide strip of adhesive Velcro is shown on the right side surface of the TV in Photo #10 below.

**1" wide self-adhesive 'hook' type  
Velcro attached along full length  
left and right side of LCD TV**

Actually the TV is attached to these left and right side aluminum brackets with strips of 1" wide Velcro with industrial strength adhesive fastening one half (the 'loop' part) of the Velcro to the aluminum bracket and the other half (the 'hook' part) of the Velcro to the plastic case sides of the TV itself. No mental hardware of any kind attaches to the TV - only the adhesive side of the Velcro.

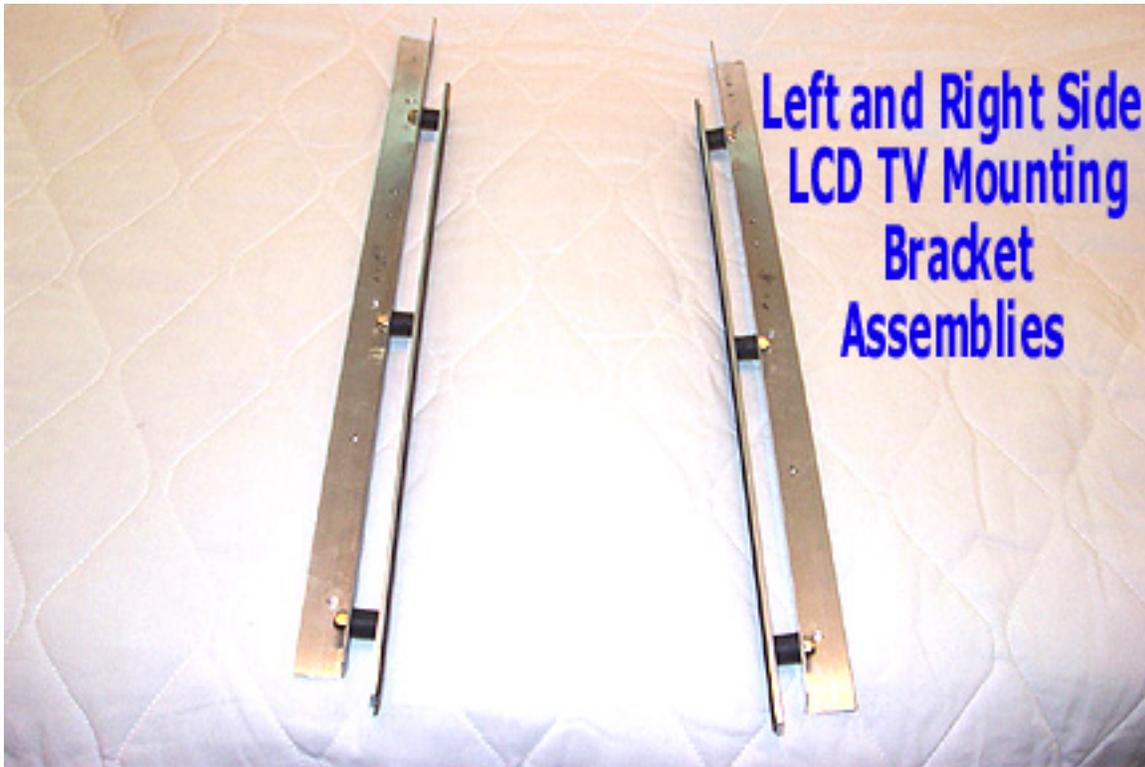
PHOTO #11

To protect this TV from the shock and vibration it will be subjected to in the motorhome travel environment, the TV was mounted to the rear of the door with quantity 6 rubber shock isolators. These isolators are part of two fabricated aluminum mounting bracket assemblies (left side and right side) holding the TV to the door as shown in Photos #11 and #12 below.

General fabrication details for the two required aluminum mounting bracket assemblies are shown in Photos #11, #12, #13 and #14 below.

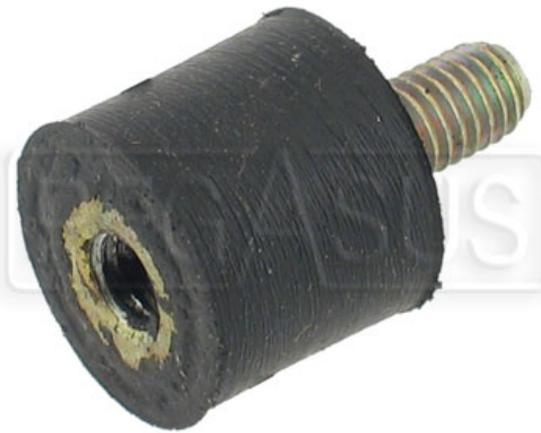
**PHOTO #13**

Photo #13 above shows one of the quantity 6 P/N 3049-02 Rubber Shock mounts used to protect the Samsung LCD TV from road shock and vibration. Both the stud and the insert are size 10-32 threads.
